THEME MEETING AND ROUND ROBIN EXERCISE ON PUSHOVER TEST ON PROTOTYPE RCC STRUCTURE, 24-25 March, 2010

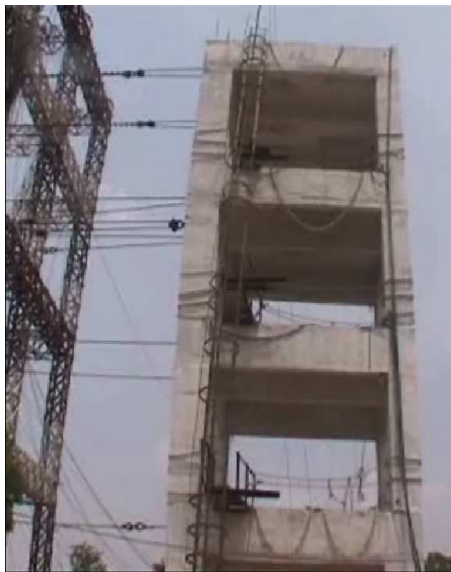
The theme meeting was followed by the experiment, which was inaugurated by Chairman, Atomic Energy Commission along with Director, BARC and Director-General, CPRI. The structure was tested till failure. Fig 1 shows the structure being tested at the tower testing facility at CPRI Bangalore.

Fig 1 Testing of Original Structure

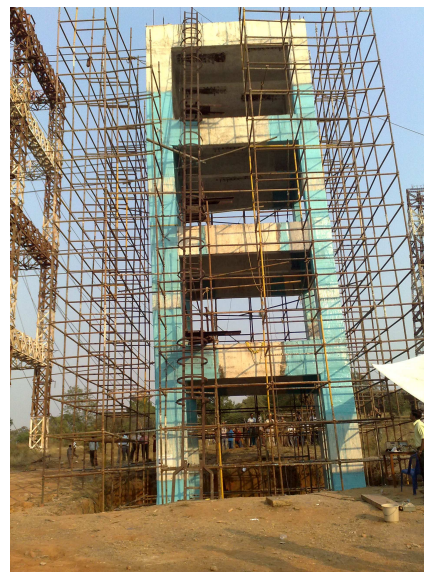
Fig 2 Testing of Retrofitted Structure

structure was tested till failure. Fig 2 shows the retrofitted structure being tested at CPRI Bangalore. Fig 3 shows the theme meeting in progress and the participants taking part in the experiment.

This structure was then repaired and retrofitted using Fiber Reinforced Polymer Composites (FRPC). Again, two day theme meeting preceded the test, where Dr. Ramesh Babu, CPRI gave the welcome address and Dr. G.R. Reddy, BARC briefed all the participants about the exercise. Researchers, working in the field of pushover analysis and repairs and retrofitting of RCC structures participated in the exercise. The institutes/organizations who participated in the second phase of the exercise included, BARC, NPCIL, DCS&EM, IIT Bombay, IISc Bangalore, CPRI Bangalore, SERC Chennai, Thapar Institute of Technology Patiyala, UVCE Bangalore, IIIT Hyderabad, SIT Tumkur and PSN College of Engineering Tirunelveli, Sardar Patel College of Engineering, Mumbai. Binyas Contech Pvt. Ltd., Bangalore and R&M International, Mumbai provided the necessary support for repair and retrofitting of the structure. On the next day, the

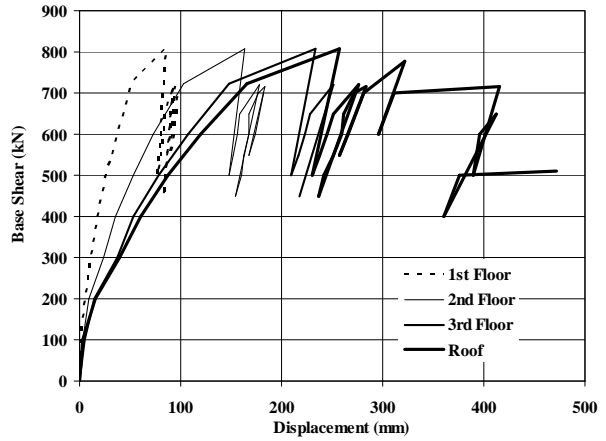
The pushover curves as obtained for as built and retrofitted structure are shown in Figs 4 and 5 respectively. The curves were plotted till large damage occurred at various locations and no significant lateral load resistance remained in the structure.

As seen from the plots, the original structure could resist a peak base shear of around 900 kN. During the test, the structure displayed various failure modes and at the end of the test, the structure could not resist any significant lateral load. However, the structure after being repaired and retrofitted with the FRPC could be restored up to almost 90% of its original state and the retrofitted structure could resist a peak base shear of around 800 kN. Till date, almost all the tests

on FRPC retrofitting have been conducted at component level or small scale structural level. The results of this test could therefore very well prove the efficacy of the retrofit system using FRPC.

Fig 5 Pushover Curve for retrofitted structure

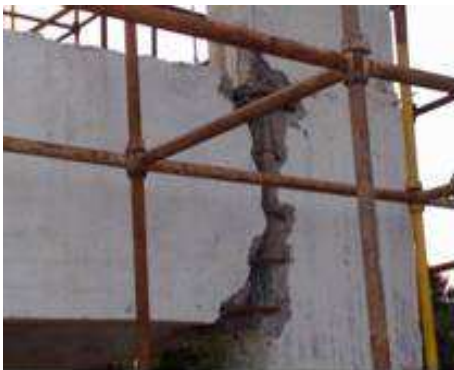
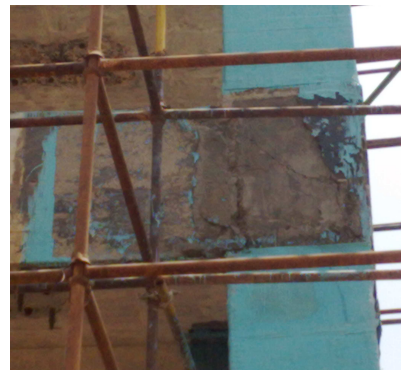
A few failure patterns of the as built and retrofitted structure are shown in Figures below. Fig 6 shows typical beam failures observed in the test. The beams displayed various flexural and flexural-shear cracks. Spalling of concrete can be observed on the tension face of the beams.

Fig 6 Failure of Beams of as built and retrofitted structure

The structure could successfully pushed back to original geometric position, repaired and retrofitted with FRPC to get the original capacity of the structure. After retrofitting, the failures were modified, first in terms of non-spalling of concrete due to good confinement provided by FRPC and second, the failure modes and locations also got shifted from joints to the beams and columns.

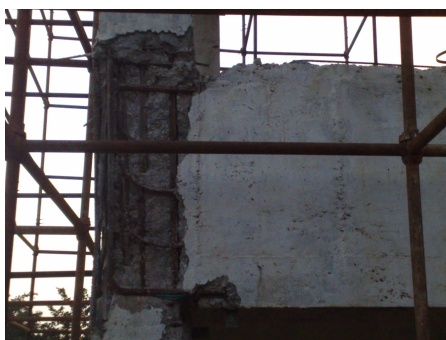
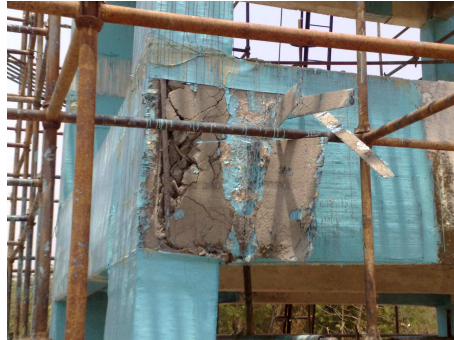
Fig 7 show typical joint failures observed in the structure.

Fig 7 Joint failures of as built and retrofitted structure
